NE Park District

Cheney Lake Park

Site Inventory
& Analysis

L1.0
sheet X of X

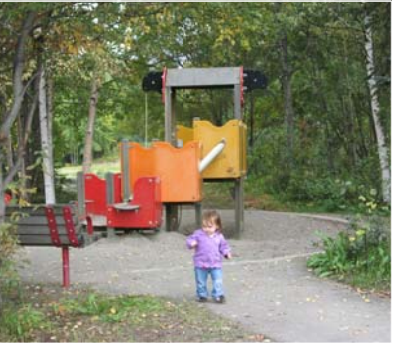
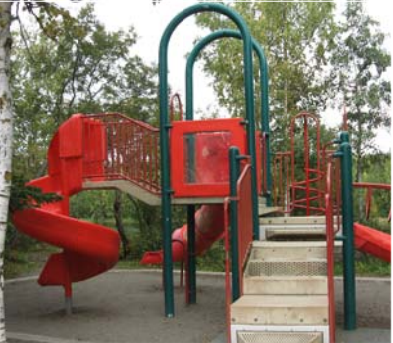
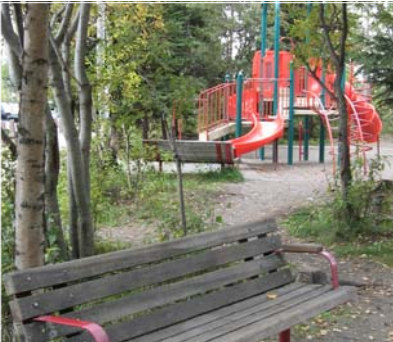
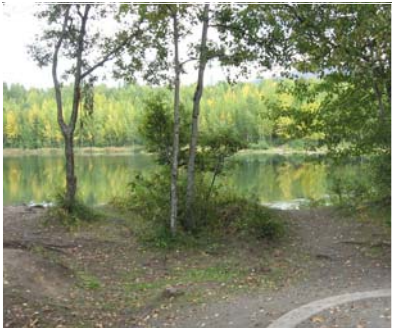
Photo Inventory

No.	Item	Description	Issues/concerns
1	Play Structure	ages 5-12, metal/plastic, Gametime(?)	Poor condition, broken slide, missing elements
2	Play Structure/ sand play	ages 2-5 wood/plastic, Kompan	Fair condition, missing a pull rope
3	Lamb Spring Toy	single seat, wood/metal, Kompan,	Fair condition, paint chipped and faded
4	Safety Surface	Poured-in place	Good condition
5	Safety Surface	Sand	Depth Inadequate, hardpan

Equipment does not meet ADA. Play structure needs to be coordinated with manufacturer for ADA upgrades; surfacing change may be requied to create more accessible play events.
