7122 E. 6th Avenue NE Park District Northeast Community Council Legis Dist 19J; Assem Dist 5 8.04 acres

Creekside Park Site Inventory L1.0 & Analysis --- x

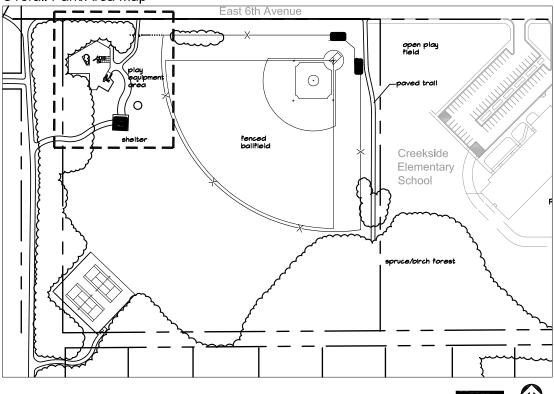
Overall Park/Area Map

Vehicle Gate Bollards Existing Vegetation Timber Edging -Dog Station Baseball Field , trashcan Asphalt Trail Existing Vegetation Concrete pad -Picnic Table icnic Shelter

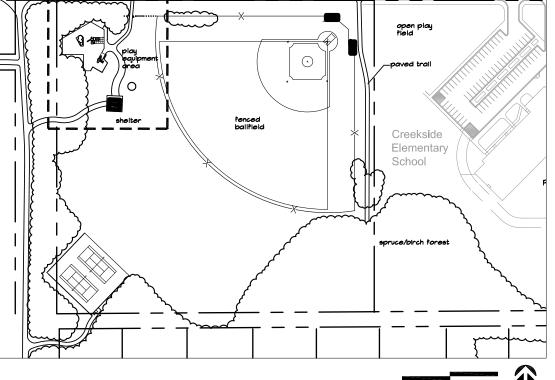
Photo Inventory

Asphalt trails on the west, south, and east perimeters. Condition fair to poor. Cracks, heaving and plant root damage has created tripping hazzards.

No.	Item	Description	
	1	Big Toy Play Structure	ages 5-12, xx events, metal/wood, multiple play events	Appearance 4; Safety 2; Activities 4
	2	Big Toy Play Structure	ages 2-5, xx events, metal/wood, multiple play events	Appearance 1; Safety 1; Activities 4
	3	Safety Surface	rubber tile	Appearance 1; Safety 1
	4	Safety Surface	pea gravel	Poor condition, plants growlng at edges

Equipment does not meet 50% requirement for ADA. Needs accessible swing element; play structure needs to be coordinated with manufacturer for ADA upgrades; one spring toy shuld have accessible surfacing.
