Birchwood Community Council

Position Paper - Case 2007-093, September 8, 2008

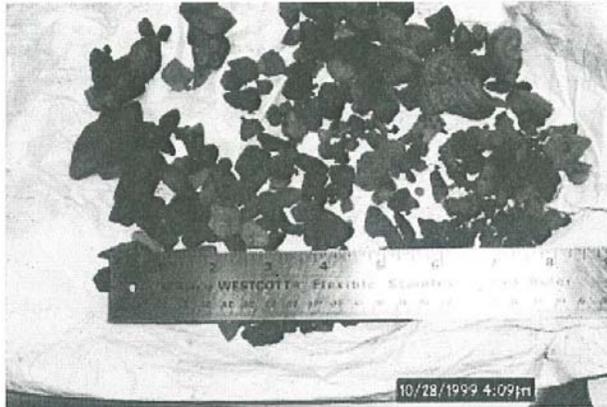
Figure 13. Material brought up during re-drilling of MW-101, from approximately 121 feet below ground surface.

drilling process was washed with clean water and contains alluvial gravels (Figure 13). Most of the wells in the Goldhill Road study area are finished at a similar depth below ground surface (although a more complete survey will confirm this); it is presumed that most of these wells are in a similar portion of the aquifer. It can be surmised that the domestic wells are completed in an ancient riverbed which is conveying water that remains perched due to the presence of a clay layer identified during the redrilling of MW-101, and described in the new well log for MW-101 (Appendix G). Similarly, the material at the bottom of the Yellow Eagle 1999 pit have been classified as “thawed and frozen gravels” by Yellow Eagle’s consulting geologist. From preliminary elevation data, it is determined that the bottom of the 1999 pit is lower in elevation than the bottom of any of the wells that experienced problems in the Goldhill Road area. The only possible exception is MW-101 after it was redrilled. Further surveying, as discussed, will confirm this.
